DEPARTMENT OF NATURAL RESOURCES  
DIVISION OF OIL, GAS AND MINING

RE: Site Inspection, W.K. Enterprises, Dunn Mine, S/037/017, San Juan County, Utah

Purpose of Inspection: To become familiar with the site and evaluate the current status of the mine.

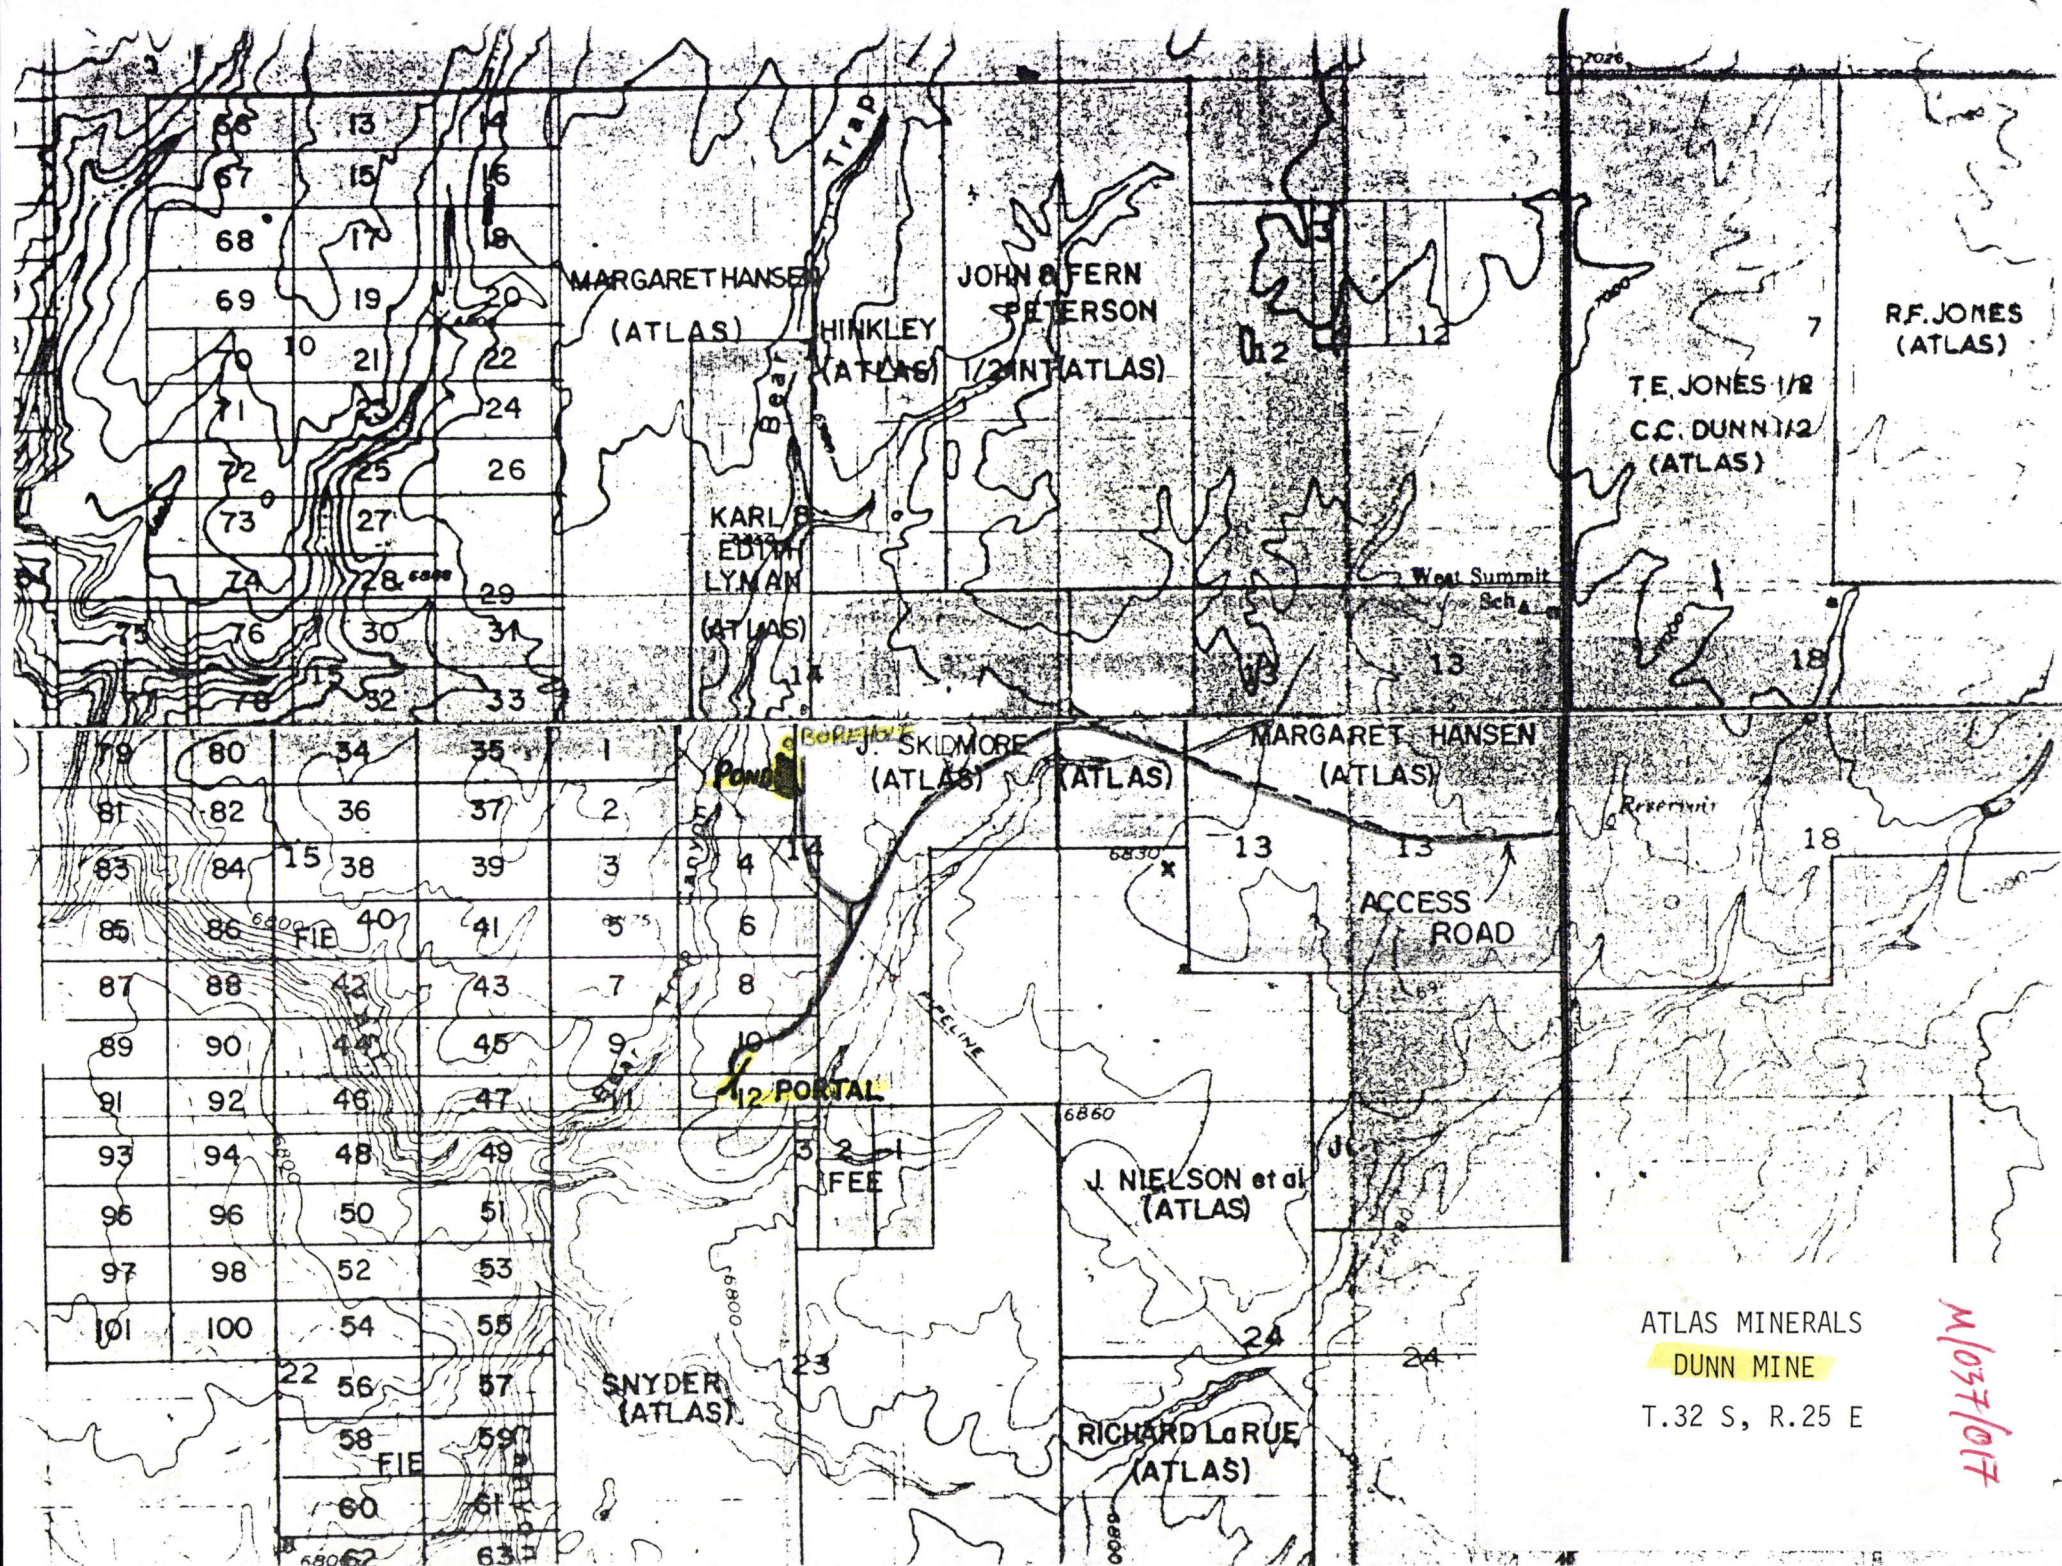
ATLAS MINERALS  
DUNN MINE  
T.32 S, R.25 E

M/037/017

On the larger mine site map submitted by Atlas, there is a road shown going to the south of the mine site to a powder magazine. We walked this road looking for any remains of a powder magazine and found nothing. Access to this road was restricted by a locked gate.
